NASA/TM-2002-211645
ARL-TR-2711

Failure Analysis of a Helicopter External Fuel-Tank Pylon

John A. Newman
U.S. Army Research Laboratory
Vehicle Technology Directorate
Langley Research Center, Hampton, Virginia

April 2002

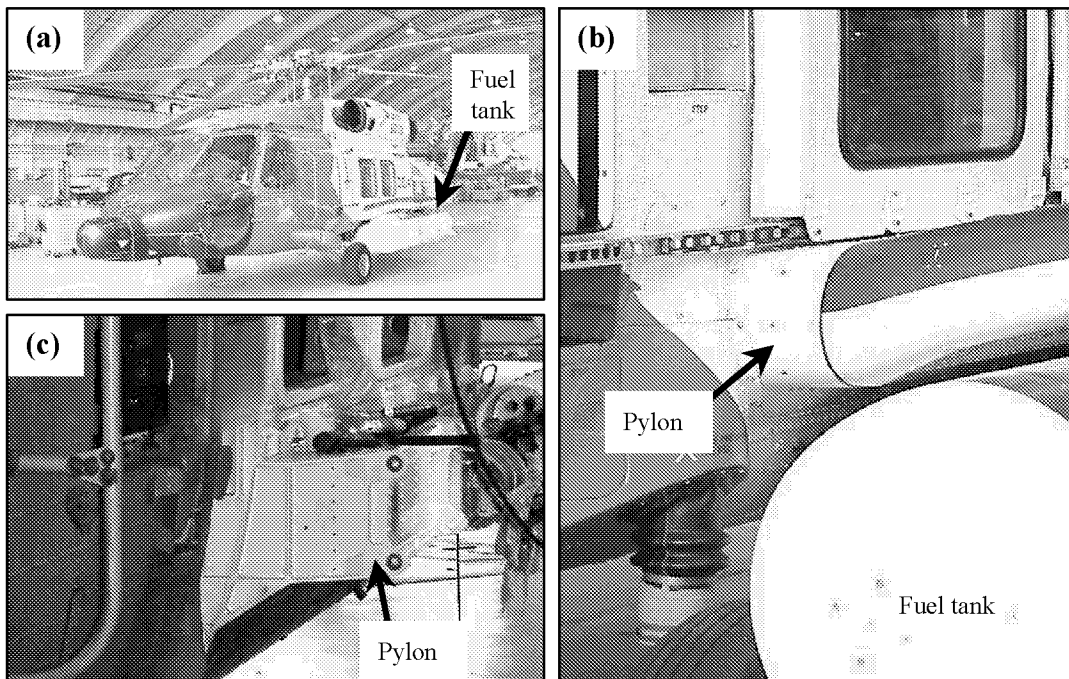
Figure 1. Photographs are shown of the external pylon-mounted fuel-tank assembly on the HH-60 helicopter. (a) A 120-gallon fuel tank is shown on the fuselage. (b) A more detailed photograph of the fuel-tank pylon attachment is shown. (c) A pylon is seen after the fuel-tank assembly was removed for inspection.

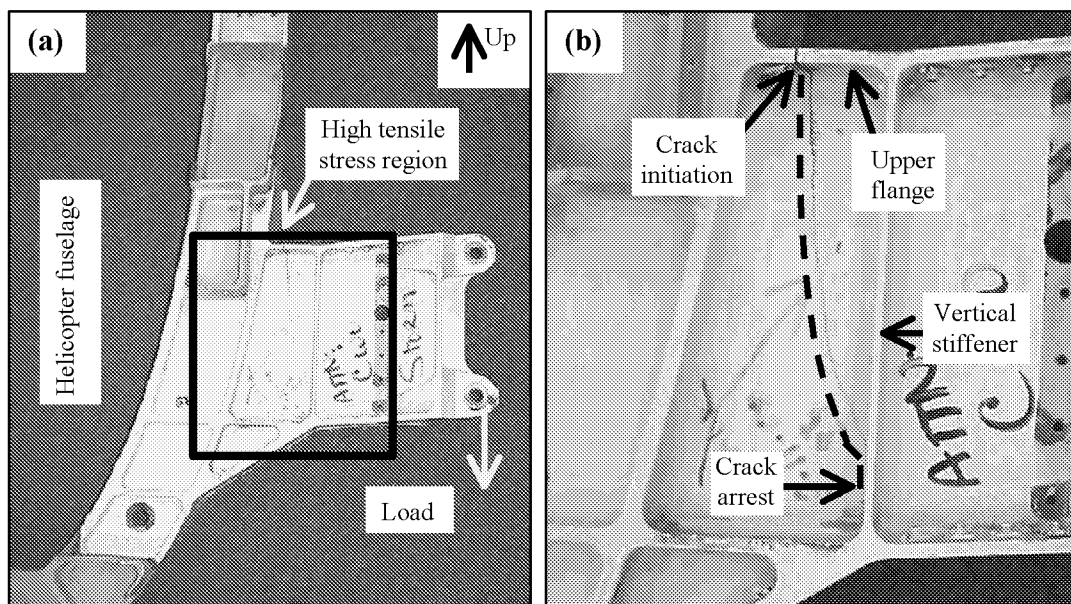
A photograph of the cracked pylon is shown as Figure 2a. The left curved-side of the pylon was mounted vertically to the helicopter fuselage; the arrow in the upper-right corner of Figure 2a indicates the vertical-up direction. The fuel-tank assembly was attached to the pylon through the two holes on the far right side of Figure 2a. Loads applied to the pylon are nominally expected in the vertically downward direction, applied at the end of the horizontal (cantilever) portion of the pylon, creating high bending stresses in the corner region of the pylon as indicated in Figure 2a. The crack appears to have initiated at fastener holes in this high stress region and propagated in a vertically downward direction. Eventually the crack propagated into a vertical stiffener and appeared to have arrested. Figure 2b is a more detailed view of the crack region outlined in Figure 2a. The dashed line in Figure 2b parallels the crack from the apparent region of crack initiation (fastener holes in the upper flange) to crack arrest at a vertical stiffener.

Figure 2. Photographs of the cracked pylon are shown. (a) A photograph of most of the pylon is shown. (b) A more detailed image is given of the cracked region.

The crack found in the fuel-tank pylon initiated at corrosion pits in the region where the highest stresses were expected. As shown in Figure 2a, vertical-downward loading on the pylon creates a high-stress region in the corner where the cantilever meets the vertical portion of the pylon. The stress concentration effect of fastener holes in this region further increases the local stress state near these discontinuities (ref. 13). Finally, corrosion pitting in these fastener holes creates rough surfaces that further increase the severity of the local stress state (refs. 14-16). Due to these three factors (pylon loading, fastener hole geometry, and corrosion pits) the highest local stress occurred at the fastener hole of Figure 3b, the crack initiation site.

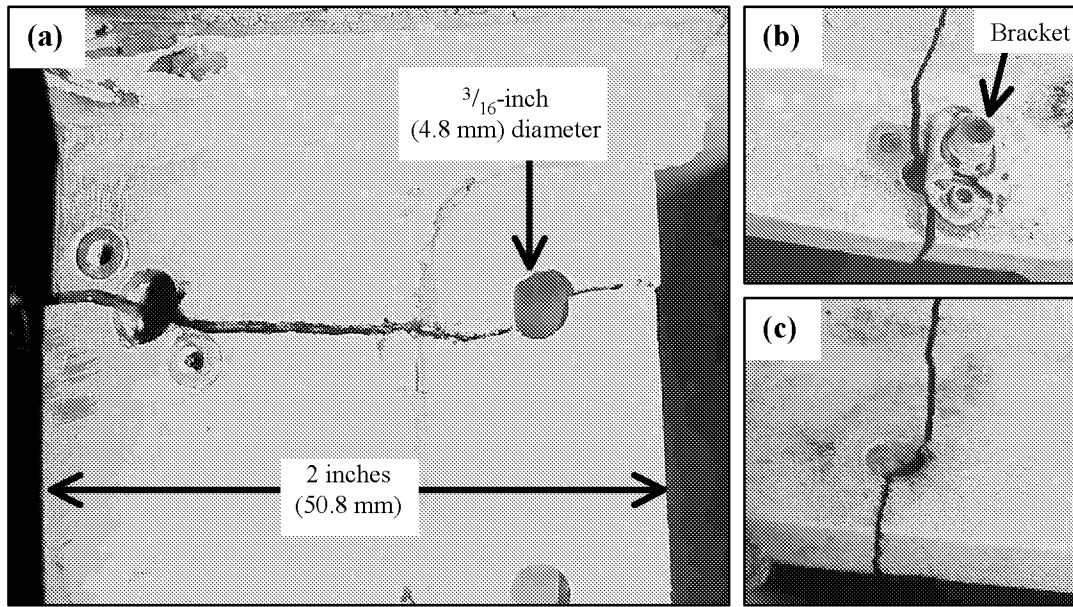
The top of the pylon upper flange, in the crack initiation region, is shown in Figure 3a. Here, the crack is seen bisecting two fastener holes, each $\frac{3}{16}$ -inch (4.8 mm) in diameter; presumably, the crack initiated at one of these holes. The bottom surfaces of the upper flange near these fastener holes are shown in Figures 3b and 3c. The two smaller holes adjacent to the large hole located on the left of Figure 3a were used to attach the bracket shown in Figure 3b. Results presented later in this paper indicate that crack initiation occurred at the fastener hole shown in Figure 3b.

Figure 3. Photographs of the crack initiation region are shown. (a) A photograph of the crack intersecting two fastener holes on the top of the upper flange is shown. (b) The fastener hole on left of (a) is shown from the underside of the flange. (c) The fastener hole on right of (a) is shown from the underside of the flange.

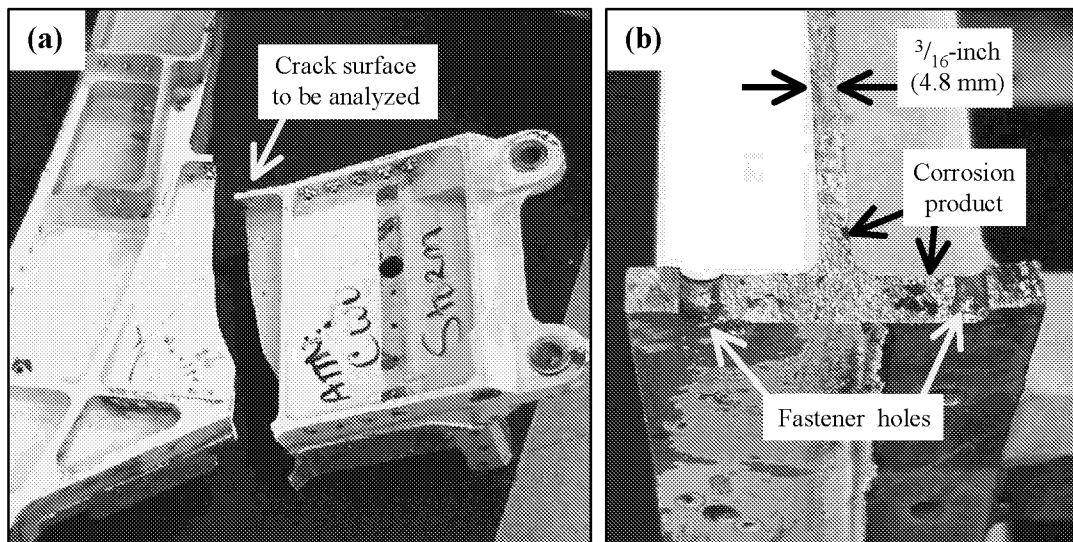
Figure 4. Photographs of the broken pylon are shown. (a) A photograph of the broken pylon is shown. (b) A detailed photograph is given of the crack surface in the crack initiation region.

initiation appeared to occur), and a portion of the web, is shown in Figure 4b. Visual inspection of the crack surfaces revealed dark-colored regions on the crack surfaces, primarily near the fastener holes where the crack appeared to initiate. These dark spots, indicated in Figure 4b, are corrosion products (likely oxide debris) that are typically produced during fatigue crack growth of aluminum alloys in an aggressive environment (refs. 4, 5). A photograph of the crack surface as it propagated from right to left into the vertical stiffener is shown in Figure 5. To the right of the curved final crack front, the fatigue crack surface is covered with a uniform dark colored corrosion product layer. To the left of the crack front, the fracture surface (produced as the cracked pylon was broken) is clean and free of corrosion products.

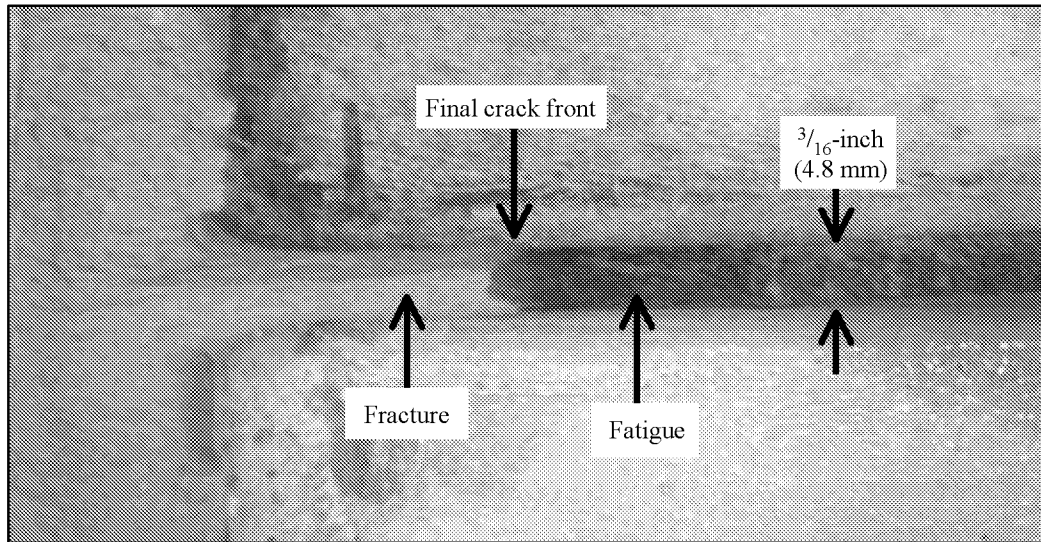
Figure 5. A photograph of the crack surface as the crack propagated into the vertical stiffener is shown.

The striation markings seen in Figure 9d indicate that rapid crack propagation occurred in the pylon webbing (approximately 1.5 mm of crack growth per 1000 load cycles). As the crack grew, increases in ΔK and fatigue crack growth rates likely occurred. Pylon failure was prevented because a vertical stiffener deflected the crack causing crack arrest. Cracks tend to propagate in the direction perpendicular to the principal (largest) normal stress, the orientation where the mode I stress intensity factor (K_I) is at its maximum value and the mode II stress intensity factor (K_{II}) is zero (ref. 17). This stiffener likely diverted the crack from principal stress directions, resulting in mixed-mode crack-tip loading (*i.e.* both K_I and K_{II} are non-zero) and a reduction in K_I , the crack driving force. Crack arrest was likely a result of a reduction in crack driving force and crack-face contact due to mode II (sliding-mode) displacements further reducing the fatigue crack driving force (refs. 18, 19). The crack surface corrosion product in Figure 5 was likely produced by sliding-mode contact of rough crack surfaces.

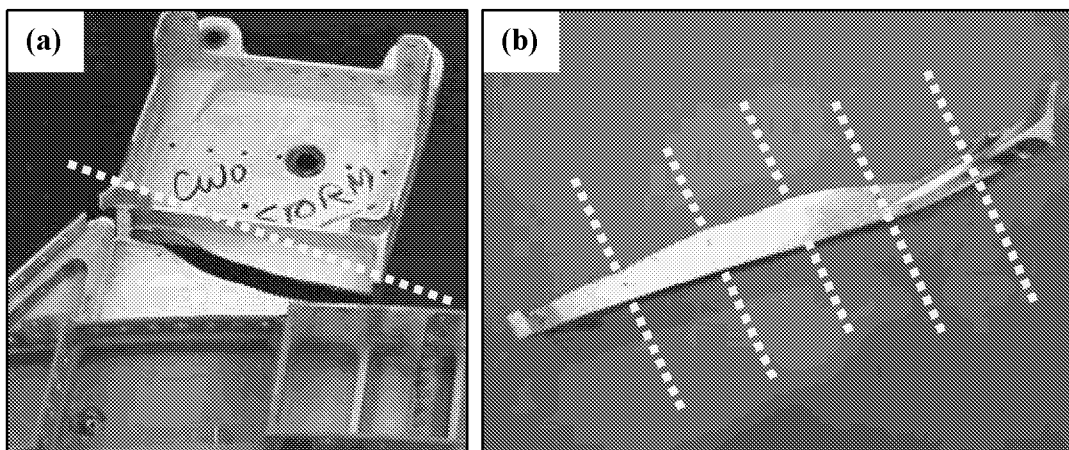
A more detailed examination of the crack surface was performed with a scanning electron microscope (SEM). The smaller piece of the broken pylon, shown in Figure 4a, was too large for SEM examination and was cut into smaller pieces. First, a single cut was made (indicated in Figure 6a by the dashed line) parallel to the crack so that the entire crack surface was contained in a strip of material approximately 12-inches (0.3 m) long. Five additional cuts were made normal to the crack surface (indicated in Figure 6b with dashed lines) dividing the crack surface into six pieces, each approximately 2-inches (50 mm) long. The six pieces of the crack surface were small enough to be accommodated in the SEM. Care was taken not to cut through regions containing important crack-surface features.

Figure 6. Two photographs are shown to illustrate how the broken pylon was cut for SEM analysis. (a) The first saw cut removed the crack surface from the pylon. (b) The crack surface was then cut into six smaller pieces.

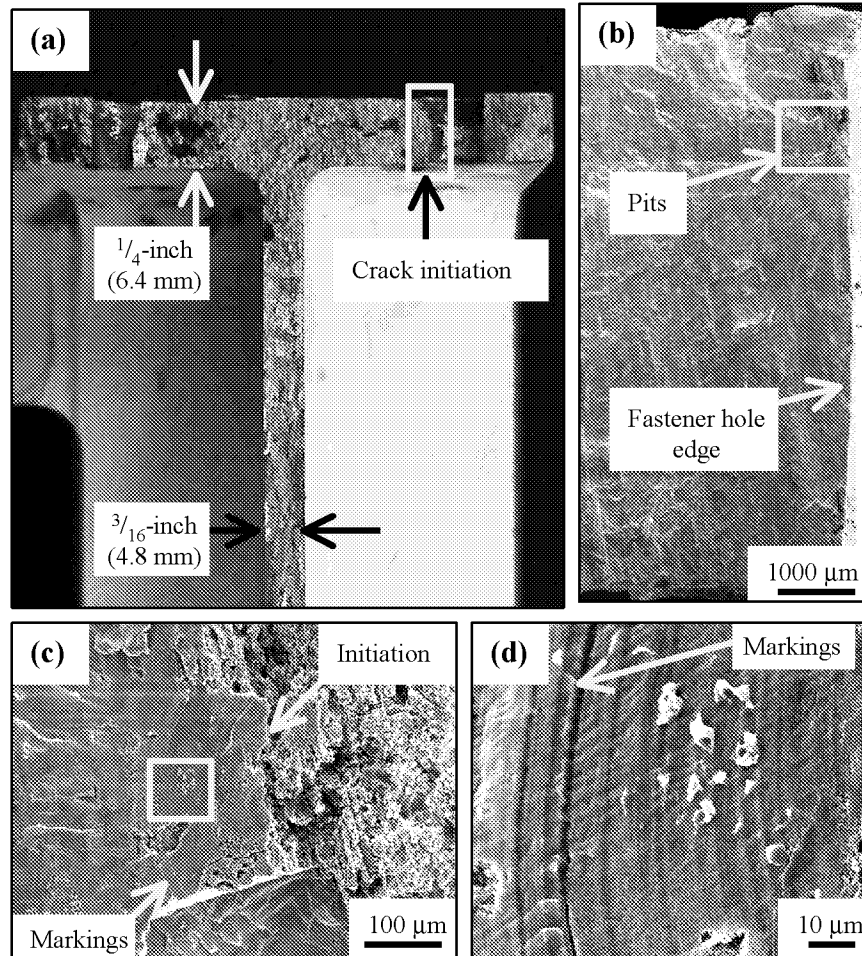
SEM examination of the clean crack surface revealed crack-surface deformation markings, evidence that crack propagation was a result of fatigue loading. The majority of the crack surface did not exhibit deformation markings, but those that were found revealed that crack initiation occurred at corrosion pits in the fastener hole of Figure 3b. The photograph of the crack surface in Figure 7a shows the region of crack initiation; crack initiation occurred at the fastener hole in the upper right corner of the figure, highlighted with a box. The crack surface in Figure 7b is a higher-magnification image of the crack initiation region highlighted (box) in Figure 7a. A region of corrosion pitting is noted in Figure 7b along the inside edge of the fastener hole (right side of the photograph). The region of crack initiation noted in Figure 7b is shown at higher magnification in Figure 7c. Corrosion pits are seen as a rough-textured region on the right side of Figure 7c. Deformation markings on the crack surface are barely visible in Figure 7c. The curved dotted line in Figure 7c shows the curvature of the deformation marks (concave to

the right) indicating that crack initiation occurred at the corrosion pits seen on the right side of the figure. These marks are better seen at higher magnification in Figure 7d.

Figure 7. The crack initiation region is shown in a series of images, at increasing magnification. (a) Photograph of the crack surface in the pylon upper flange region is shown. Also shown are micrographs of (b) crack surface at edge of fastener hole surface, (c) crack initiation at corrosion pits, and (d) crack surface markings at high-magnification in crack initiation region.

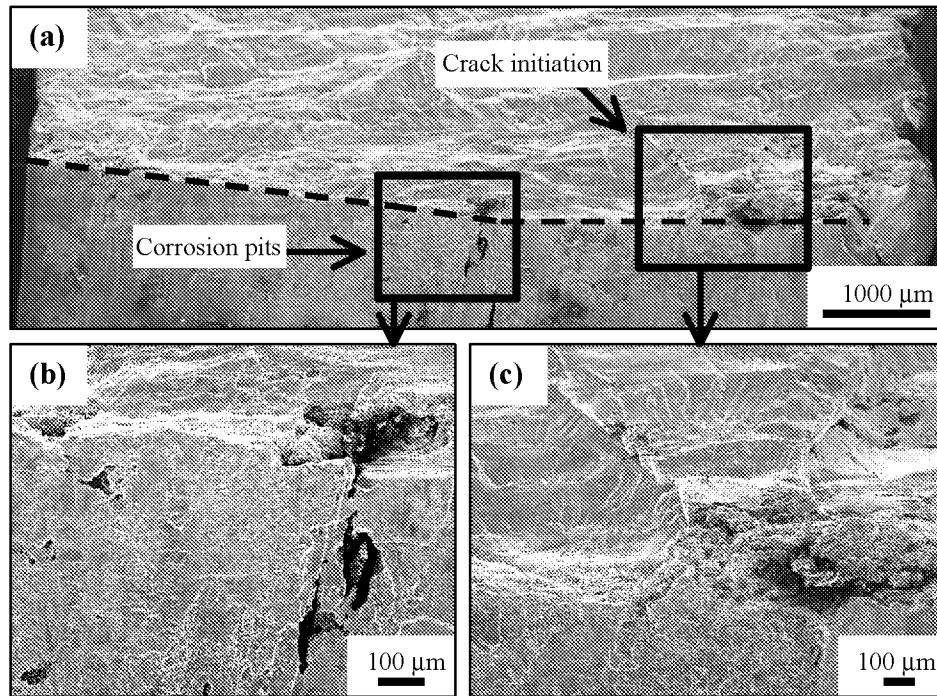
SEM images of the crack initiation region of Figure 7 are shown at a different angle in Figure 8 to illustrate the complex nature of the crack surface and to highlight regions of pitting that did not result in crack initiation. Here, the crack surface was viewed at an angle 45° from the direction normal to the crack surface, and the specimen is rotated 90° (with respect to the orientation of Figure 7) so the fastener hole is oriented horizontally. In Figure 8a, the intersection of the crack surface with the edge of the fastener hole is indicated with a dashed horizontal line; the surface of the hole and the crack surface are below and above the dashed line, respectively. The upper and lower surfaces of the upper flange (shown in Figure 3) are the edges seen on the extreme right and left sides of Figure 8a, respectively. The boxes in Figure 8a identify two regions of corrosion pitting in the fastener hole: one where cracks did not initiate (left box) and one where cracks did initiate (right box). These regions are shown at higher magnification in Figures 8b and 8c, respectively.

Figure 8. Micrographs of the crack initiation region, viewed at a 45° angle to the crack surface, are shown. (a) The crack surface at the edge of the fastener hole surface is shown. High-magnification micrographs are shown of corrosion pits (b) where cracks did not initiate and (c) where cracks initiation occurred.

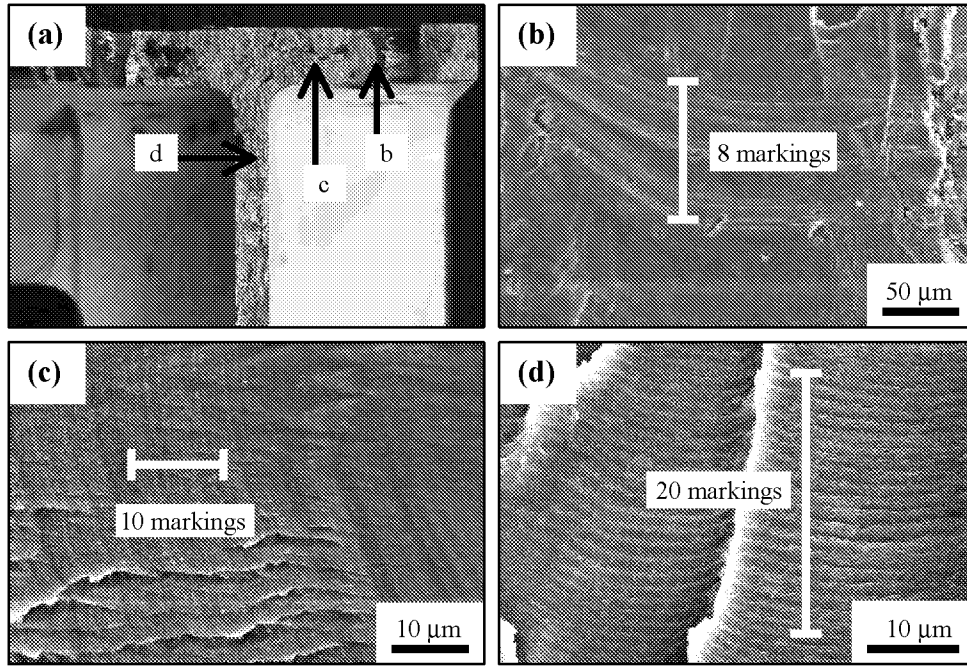
Evidence of crack-surface deformation marks at three locations along the crack surface is shown in Figure 9. These three locations, identified in Figure 9a as b, c, and d, are shown at high-magnification in Figures 9b, 9c, and 9d, respectively. The markings observed in Figures 9b and 9c are not equally spaced, possibly suggesting that complex variable-amplitude loading occurred. The deformation markings shown in Figure 9d are equally spaced and exhibit the morphology typical of fatigue striations. The average spacing between deformation markings is determined by counting the number of marks intersecting lines along the crack growth direction (*i.e.* normal to the marks). In Figure 9b, 8 marks are counted along a line 100 μm long. For Figures 9c and 9d, 10 marks and 20 marks are counted along lines 15 μm and 30 μm long, respectively. If each deformation mark was produced by a single load cycle, the average fatigue crack growth rates corresponding to Figures 9b, 9c, and 9d would be 1.2×10^{-5} m/cycle, 1.5×10^{-6} m/cycle, and 1.5×10^{-6} m/cycle, respectively. The markings in Figures 9b and 9c are not regularly spaced and may not have been produced by single load cycles. Therefore, these markings do not permit a good estimation of fatigue crack growth rates. The crack-surface markings seen in Figure 9d are likely striations, each produced by a single load cycle. Therefore, the calculated fatigue crack growth rate of 1.5×10^{-6} m/cycle is likely a good estimate for the crack surface of Figure 9d. Based on laboratory 7075 aluminum data, the fatigue crack growth rate for Figure 9d corresponds to values of ΔK between 15 MPa $\sqrt{\text{m}}$ and 20 MPa $\sqrt{\text{m}}$ (refs. 10, 11).

Figure 9. Micrographs of crack-surface markings are shown at high magnification. (a) A photograph of the crack surface in the pylon upper flange region is shown. High-magnification micrographs are shown of the crack surface (b) near the crack initiation region, (c) between the fastener hole and the web, and (d) in the pylon web.
